# Inspection Report

**MARLEY HITCHCOCK  
11000 NEWFOUNDLAND DOG  
ROCKVILLE, MD 20852**

Report Date: 6/23/2015

Inspection location: **11000 NEWFOUNDLAND DOG LANE** Send report to:  
**ROCKVILLE, MD 20852**  
Phone:  
County: **MONTGOMERY**  
Area/Neighborhood: Sub-division:

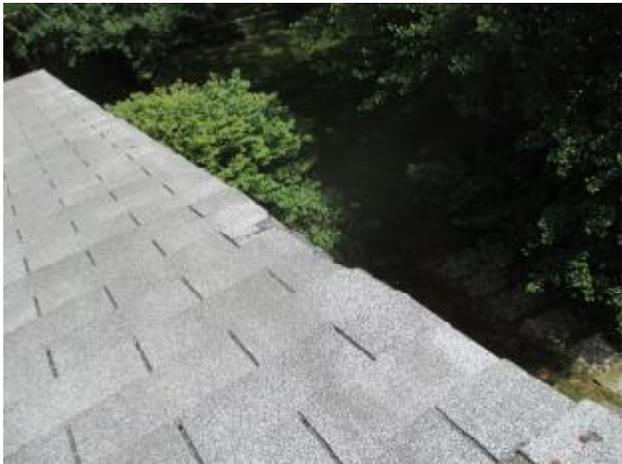
18 **OVERALL, THE SHINGLE COVER IS INTACT AND STILL IN SERVICEABLE CONDITION ( SERVICEABLE DEFINED : SHOULD 10 TO < 15 % OF THE ROOF COVER SUSTAIN DAMAGE , IT WOULD STILL BE WORTH HAVING IT REPAIRED VERSUS OFF AND REPLACING IT ALTOGETHER ) . THERE IS A SMALL GROUPING OF CHIPPED SHINGLE TABS , OVERHANGING THE RAKE AT THE RIGHT GABLE SIDE , REAR SLOPE SIDE WHERE A PIECE OF SHEET METAL WAS INSTALLED LIKELY FOR THE PURPOSE OF KEEPING WATER OUT COMPENSATING FOR THE LOSS OF THE ROOF COVER THERE. RECOMMEND TO REPLACE THE DAMAGED SHINGLE THERE. THE QUALITY AND WEIGHT OF THE SHINGLES USED HERE ARE TYPICAL OF A 25 YEARS WARRANTED FIBERGLASS COMPOSITE SHINGLE, THE ANTICIPATED SERVICE LIFE FOR A 25 YEAR SHINGLE LAID ON A MODERATE SLOPE , AS THESE ARE, MAY LAST SOMEWHERE FROM 22 TO UP TO 27 YEARS OR SO. RECOMMEND TO BUDGET FOR REPAIRS AND FOR THE EVENTUAL REPLACEMENT OF THE ROOF COVER WITHIN THE NEXT 5 TO 10 YEARS. HAVE A ROOFER OR OTHER LICENSED QUALIFIED PROFESSIONAL SUCH AS A HANDYMAN OUT FOR THE MINOR REPAIR TO AT THE RIGHT GABLE END SIDE.**

MINOR SHINGLE DAMAGE ABOVE RAKE #R

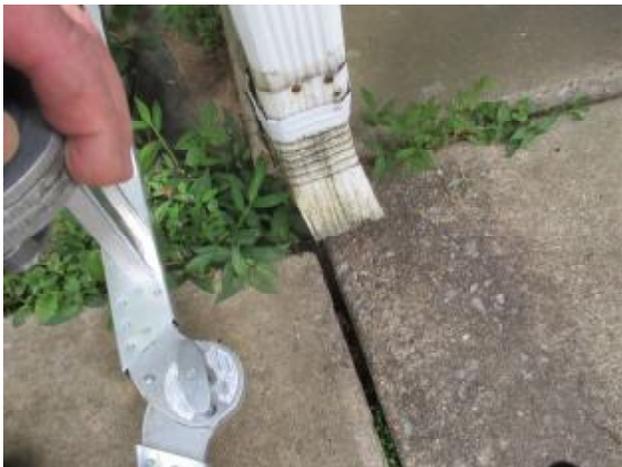
**RECOMMEND TO REDIRECT THE FLOW OF THE FRONT LEFT DOWN SPOUT OFF OF THE DRIVEWAY . THE BERING SOIL UNDER THE DRIVEWAY SURFACE HAS ERODE AWAY CREATING A VOID BENEATH THE DRIVEWAY WHERE ABUTTING THE CAR PORT PAD. AN ACTIVE WATER INTRUSION EVENT IS OCCURRING AT THE LEFT CORNER AND ALONG THE REAR WALL OF THE CEDAR LINED CLOSET IN THE BASEMENT THAT MAY BE RELATED TO THE DOWN SPOUT PLACEMENT SHEDDING IT'S WATER BENEATH THE HOLLOWED OUT DRIVEWAY AND CAR PORT PAD THERE. RECOMMEND TO ALSO CLOSE OPEN CONTROL AND TRANSITION JOINTS AT THE DRIVEWAY AND CAR PORT USING A RUBBERIZED CAULK. HAVE A PLUMBER OUT TO CHECK THE PIPE FOR THE FRONT HOSE BIB AS WELL AS IT MAY BE CAUSING THE WATER INTRUSION, IS CONDENSING , OR IS CONTRIBUTING TO IT IN SOME WAY AT VERY LEAST.**

EXTEND DOWN SPOUT AWAY FROM DRIVEWAY #R

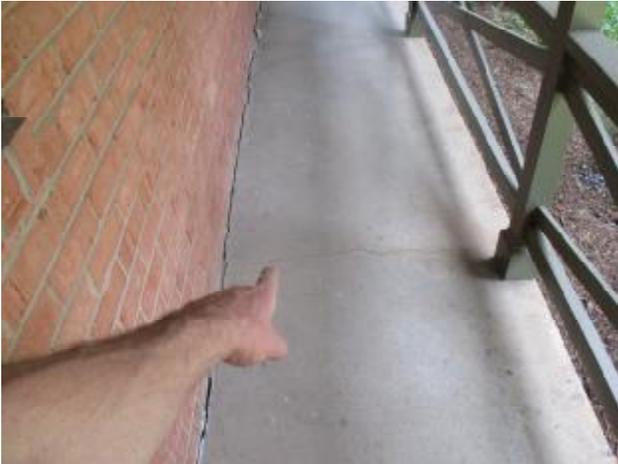
17 THE PAD OF THE FRONT PORCH HAS SETTLED RESULTING IN IT SEPARATING FROM THE EXTERIOR WALLS, ALSO, AS THE PORCH PAD HAS DROPPED OFF AT THE FRONT IT HAS RESULTED IN THE PARTIAL LOSS OF BEARING FOR THE FRONT PORCH ROOF OVERHANG COLUMN SUPPORTS. RECOMMEND TO UNDERPIN THE PAD TO KEEP IT STATIC SO THAT IT WILL NO LONGER TO CONTINUE SETTLING. SHIM THE BOTTOMS OF LOOSE POSTS AS NEEDED.

PORCH CRACK PARALLEL TO POST #GD

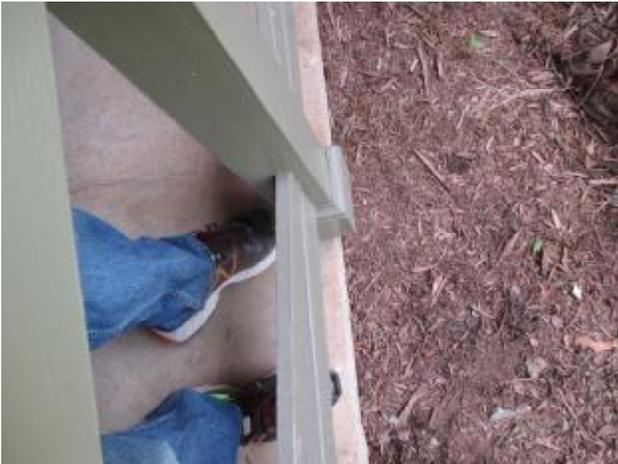
PORCH HAS SETTLED CAUSING POST TO FLOAT #GD

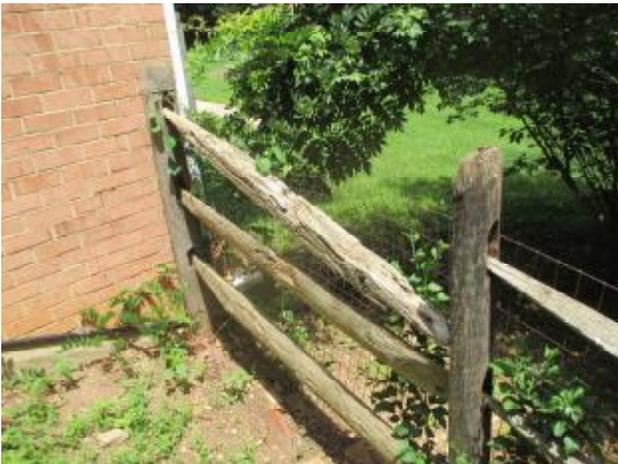
ROTTED SPLIT RAILS @ LEFT & FRONT #GD

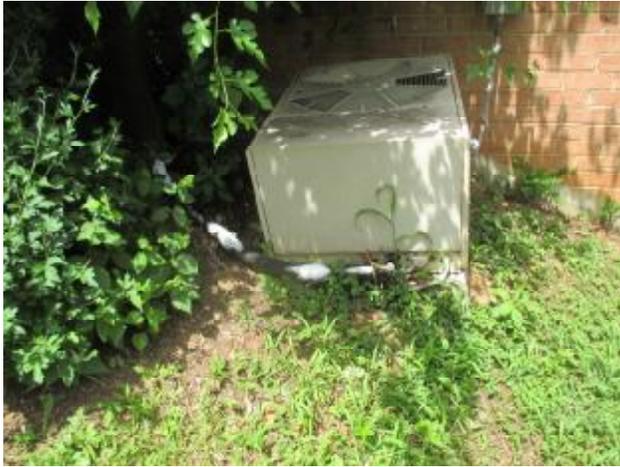
- 24 THE CONDENSER APPLIANCE WAS MADE CIRCA 1985 , WAS FROSTED UP WHEN THE INSPECTION WAS PERFORMED, THE BLOWER WAS NOT WORKING AT THE FURNACE , BUT THE CONDENSER WAS RUNNING. THE FROST UP ON BOTH COILS MAY OCCUR DUE TO POOR AIR FLOW ACROSS THE COILS, A FAILED COMPRESSOR, OR LOSS OF REFRIGERANT ALL A COMBINATION OF THE 3. AS THE BLOWER APPEARS TO BE INOPERABLE, IT IS POSSIBLE THAT IT'S FAILURE MAY ACCOUNT FOR THE LACK OF AIR FLOW CAUSING THE COILS TO ICE UP . AT ANY RATE, THE CONDENSER HAS LONG SINCE BECOME FULLY DEPRECIATED, AND HAS ALSO OUTLIVED IT'S USEFUL LIFE. THE 3 TON EVAPORATIVE COIL INSIDE IS DATED TO 1993 MAKING IT TOO DEPRECIATED AND NEARING THE END OF USEFUL LIFE. RECOMMEND TO REPLACE THE ENTIRE HVAC ARRANGEMENT, (THE FURNACE AND COOLING PACKAGE ) AS THE CURRENT APPLIANCES HAVE MAJOR EXPENSE COMPONENT FAILURES LIKE THE BLOWER, THE COMPRESSOR , ETC. HAVE A LICENSED HVAC MECHANIC OUT TO FURTHER EVALUATE AND TO WORK UP A MORE ACCURATE QUOTE.

ICE ON SUCTION LINE AND COILS

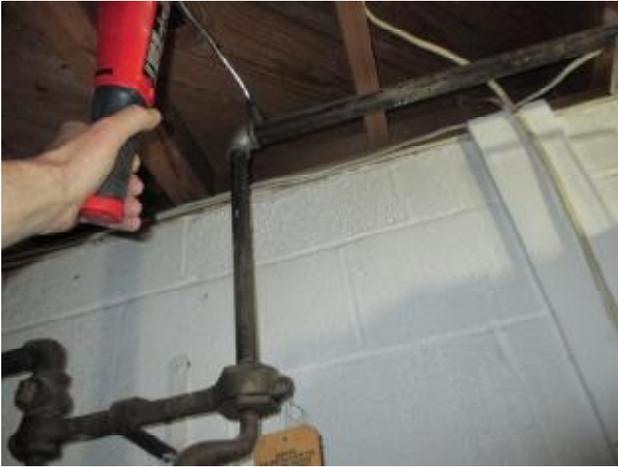
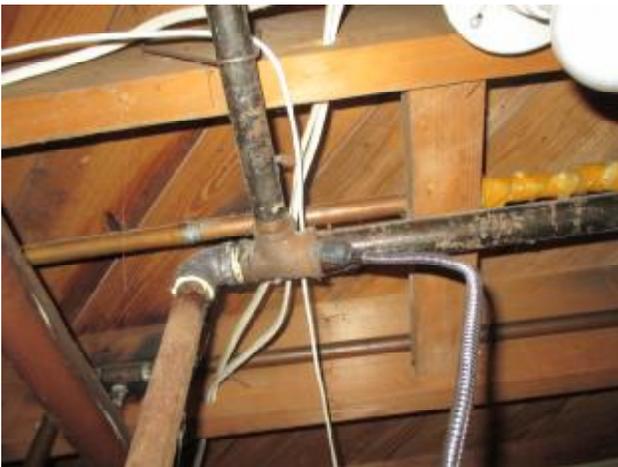
THERE ARE AT LEAST 2 GAS LEAKS OCCURRING AT THE UTILITY BASEMENT ROOM, ONE ABOVE THE METER AT THE 90 THERE, AND ANOTHER AT THE TEE FITTING ABOVE AND FORWARD OF THE WATER HEATER. RECOMMEND TO HAVE A PLUMBER / GAS FITTER OUT TO REPAIR THESE AND ANY OTHERS THAT THEY MAY UNCOVER. HAVE THE PLUMBER CHECK ALL ACCESSIBLE GAS FITTINGS FOR LEAKS AND REPAIRED, IF AND AS NEEDED.

PROBABLE GAS LEAK HERE

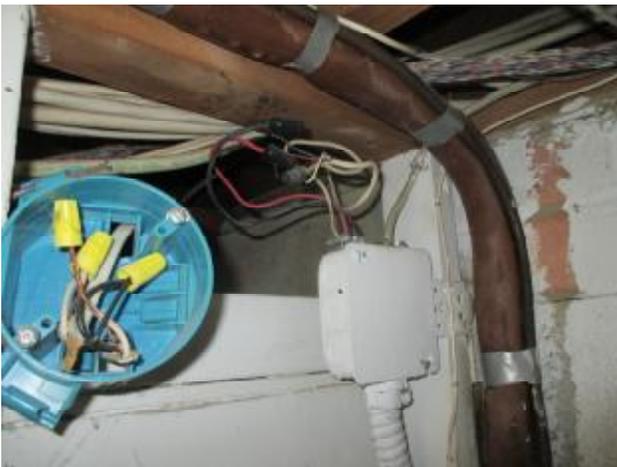
ENCLOSE WIRE SPLICES INSIDE COVERED J- BOX #EL

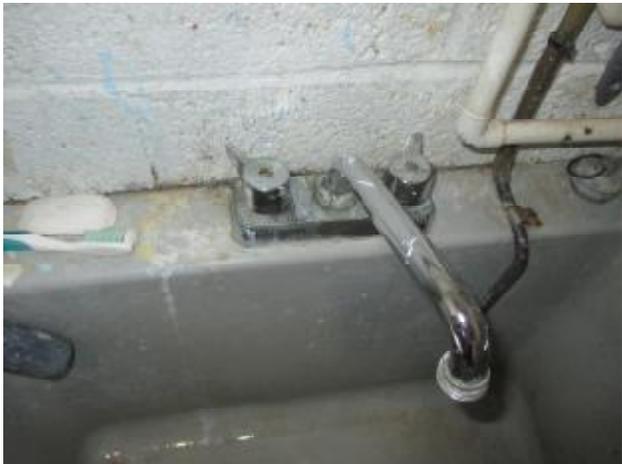
20 FROM KITCHEN PAGE : THE LAUNDRY TUB FAUCET FIXTURE LEAKS WHEN VALVES ARE OPEN. RECOMMEND TO HAVE A PLUMBER OUT TO REPAIR, OR TO REPLACE THE FAUCET FIXTURE ALTOGETHER.

LAUNDRY TUB FIXTURE LEAKS

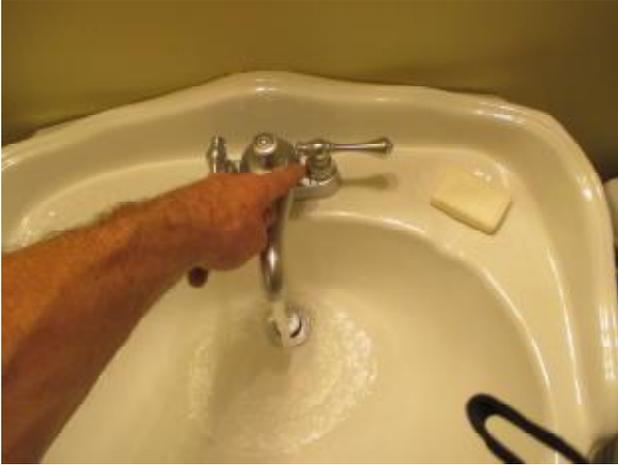
LEAK @ BASEMENT BATHROOM FIXTURE #B

THE BASEMENT BATHROOM FAUCET FIXTURE LEAKS AT THE COLD WATER SIDE WHEN THE VALVE IS OPEN. RECOMMEND TO HAVE A PLUMBER OUT FOR REPAIR.

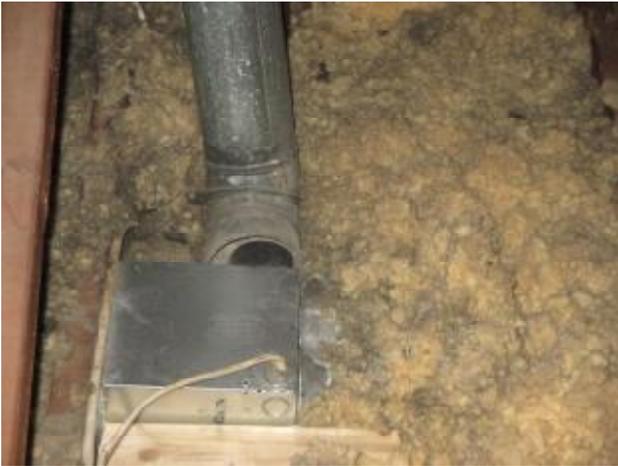
INSTALL REDUCER TO BATHROOM FAN VENT #B

**THE MASTER BATHROOM VENT FAN OUTFLOW PIPE IS OF A SMALLER DIAMETER THAN THE VENT CONNECTOR THAT IT IS TIED IN TO. RECOMMEND TO INSTALL A REDUCER TO JOIN THE TWO PIPES SNUGLY SO THAT THE FANS OUTFLOW IS ABLE TO VENT OUT OF THE ATTIC FULLY.**

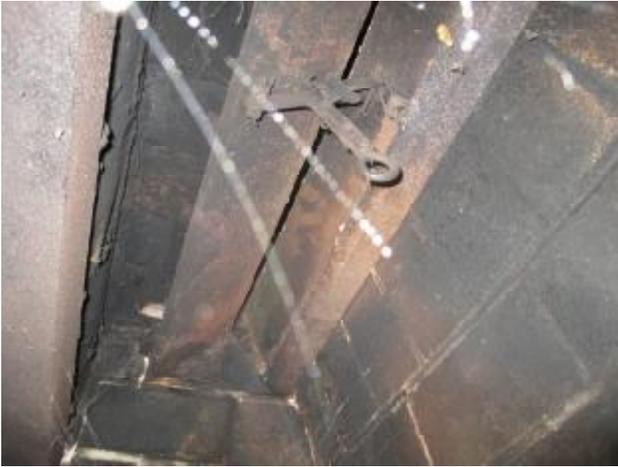
16 THE FIRE PLACE DAMPER DOES NOT SEAT WELL AS A RESULT IT DOES NOT FULLY CLOSE OFF THE FIREPLACE THROAT AND THE FLUE. RECOMMEND TO REPAIR THE DAMPER. HAVE A CSIA CERTIFIED CHIMNEY SWEEP OUT TO PERFORM A LEVEL 2 CHIMNEY EVALUATION HERE. ONE SUGGESTED IMPROVEMENT IS FOR THE OLDER DAMPER TO BE REMOVED AND A BONNET TOP DAMPER INSTALLED AT THE TOP OF THE CHIMNEY. THE REASON FOR THIS SUGGESTED IMPROVEMENT IS PRIMARILY TO PREVENT COLD AIR FROM SINKING IN TOWARDS THE FIRE BOX AND IN TO THE DWELLING. THESE TOP DAMPERS LIMI THIS OCCURRENCE SAVING ENERGY AND MAKING THE INTERIOR OF THE HOME MORE COMFORTABLE.

FIREPLACE DAMPER NEEDS REPAIR

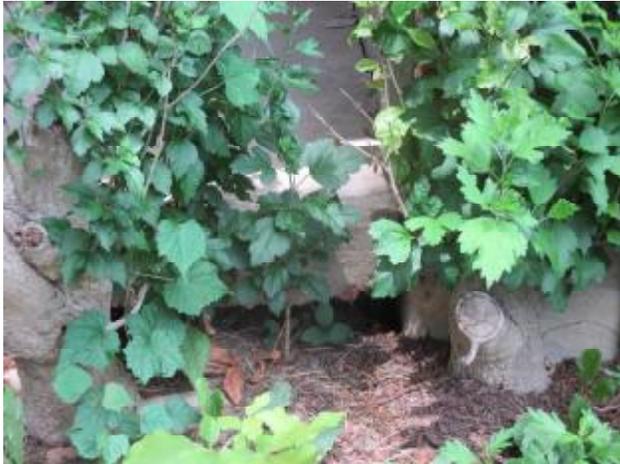
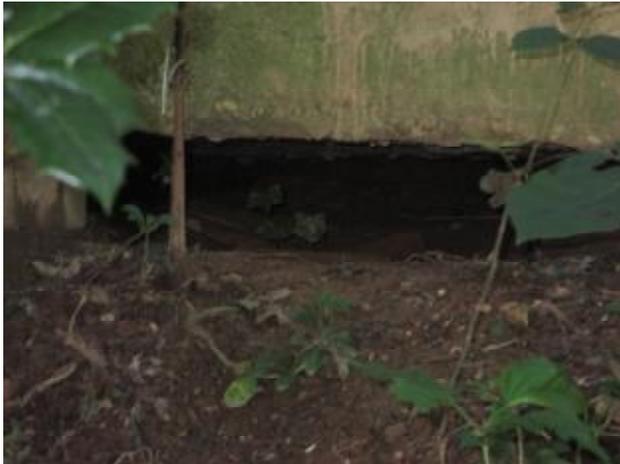
- 20 **WATER COMING OFF THE CHIMNEY AND BURROWING ANIMALS HAVE CARVED OUT A VOID BENEATH THE CARPORT PAD. THE CONCERN IS THAT AS THE CONCRETE SURFACE DESIGNED ORIGINALLY TO RECEIVE THE CONCENTRATED LOADING OF HEAVY VEHICLES WHEN THE BEARING SOIL WAS PRESENT THAT NOW WITH THE REMOVAL OF SAME, THAT MUCH OF THE PAD IS ILL SUPPORTED AND COULD CRACK AND / OR FAIL. RECOMMEND TO UNDERPIN THE PAD TO COMPENSATE FOR THE LOSS OF BEARING SOIL. SCREW PILES, HELICAL PIERS, AND / OR EXCAVATING , INSTALLING PILES, GRADE BEAMS OR OTHER SUITABLE STRUCTURAL AUGMENTATION IS STRONGLY RECOMMEND TO CONSULT AN ENGINEER TO DESIGN AS STABILIZATION PLAN, AND A CONTRACTOR TO MAKE SUITABLE REPAIRS THERE.**

VOID BENEATH THE CAR PORT PAD #GC

CLOSE UP OF SUB SLAB EROSION @ CARPORT #GC

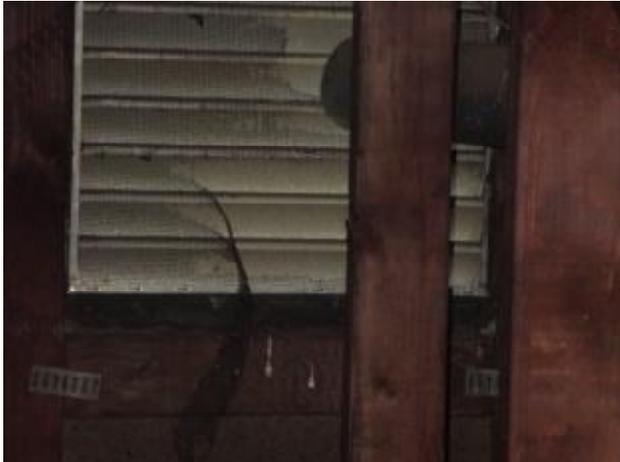
RESCREEN GABLE VENT #A

**RESCREEN THE RIGHT GABLE END SIDE LOUVERED VENT PANEL AS IT IS CURRENTLY LOOSE AND TORN.**

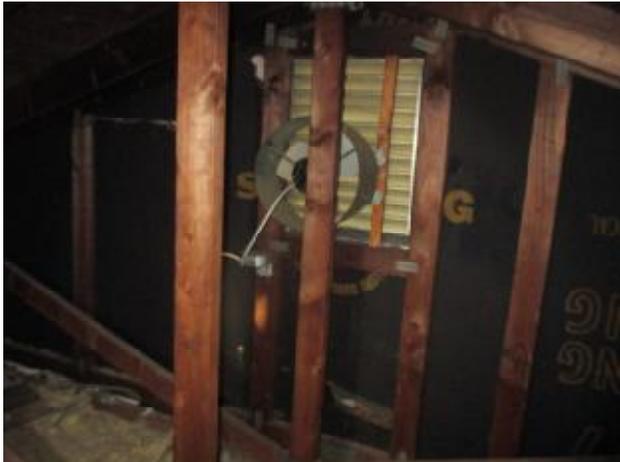
REPAIR OR REPLACE THE ATTIC FAN #A

**RECOMMEND TO REPAIR OR TO REPLACE THE INOPERABLE ATTIC FAN LOCATED AT THE LEFT GABLE END SIDE RAKE WALL ATTIC VENT.**

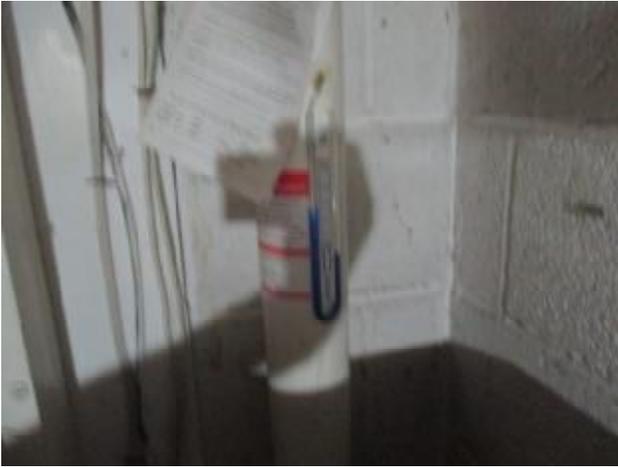
BUDGET TO REPLACE THE RADON VENT FAN AS IT MAY BE ORIGINAL ( 15 YEARS OLD ). THESE DEVICES COME WITH A LIMITED 5 YEAR WARRANTY. WATCH THE U-GAGE FOR ZEROING OUT, IF IT DOES THE FAN HAS FAILED.

U GAGE ON RADON TAP

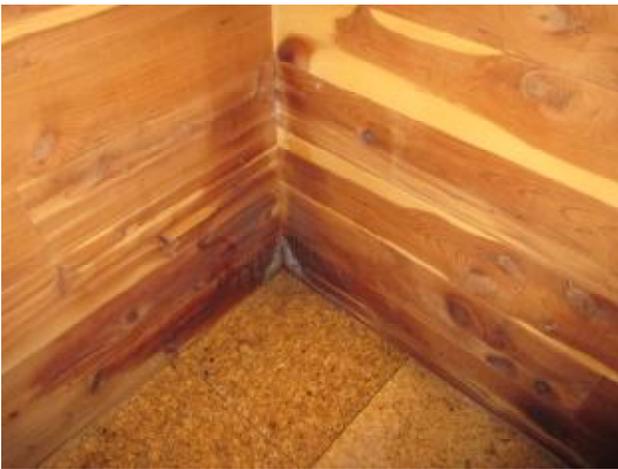
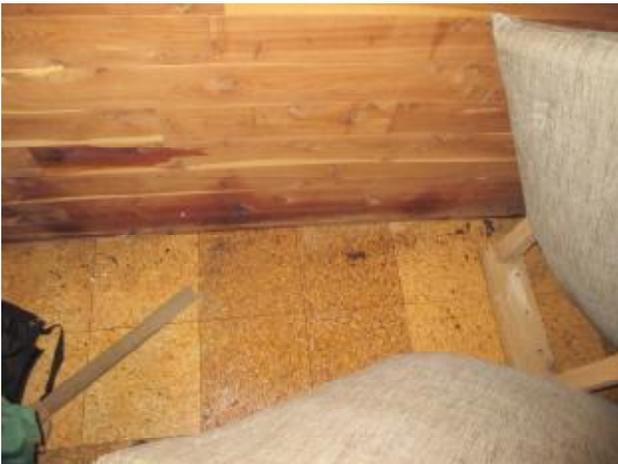
THE FOUNDATION WALLS AT THE FRONT AND SIDES HAVE RECEIVED A COATING OF A MOISTURE BLOCKING PAINT. GERENERALLY , AND THE STUD WALLS INSIDE THE MECHANICAL ROOM HAVE BEEN PAINTED AS AS SUGESTING THAT AT ONE TIME, THERE MAY HAVE BEEN A WATER ENTRY EVENT THAT OCCURRED IN THAT ROOM. AT THE LEFT UTILITY BASEMENT ROOM WATER WAS OBSERVED ON THE FLOOR AND WICKING THROUGH THE CEDAR PANELING INSIDE OF THE CLOSET . THE SOURCE OF THE WATER IS UNKNOWN HOWEVER IT IS SUPOSED THAT PERHAPS THE PLUMBING SERVING THE HOSE BIB MAY BE CONTRIBUTING TO THE WATER ENTRY EVENT. AS THE HVAC WAS EQUIPMENT WAS NOT FUNCTIONAL THE PIPE THERE MAY BE CONDENSING , OR THAT THERE IS A PIN HOLE LEAK OCCURRING THERE. THE WATER ENTRY MAY ALSO FROM THE OUTFLOW FROM THE DOWN SPOUT TERMINATING ON TO THE DRIVEWAY EXPLOITING THE OPEN JOINTS BETWEEN AND EROION BENEATH THOSE SURFACES GAINING READY ACCESS TO THE WALL AT THE CORNER THERE , OR GROUND WATER WELLING UP FROM BENEATH THE HOME IN THAT GENERAL AREA. RECOMMEND TO HAVE A LICENSED PLUMBER OUT FOR FURTHER EVEALUATION TO PERFORM A MORE TECHNICALLY EXHAUSTIVE EVALUATION OF WHETHER THIS IS A PLUMBING ISSUE OR NOT AND IF SO, TO MAKE ANY AND ALL REQUISITE REPAIRS THERE AS NEEDED. IF NOT PLUMBING RELATED THE CEDAR PANELS SHOULD BE REMOVED TO GAIN ACCESS TO WALLS IN THAT CORNER , IF COMING FROM THE COVE JOINT BETWEEN THE SLAB, AND WALL, OR THE WALLS A WATER PROFFING CONTRACTOR SHOULD BE CONSULTED AND REPAIRS MADE IN THIS REGARD. SEE ALSO, COMMENT ON THE ROOF PAGE .

WATER LEAK AT BASEMENT CLOSET
